ASBESTOS SURVEY AND ASSESSMENT REPORT

DPW PROJECT #89-773

IDAHO STATE TRANSPORTATION DEPARTMENT
DISTRICTS 04, 05 AND 06 DIVISION OF HIGHWAYS
SHOSHONE, POCA TELLO AND RIGBY, IDAHO

JULY 1989

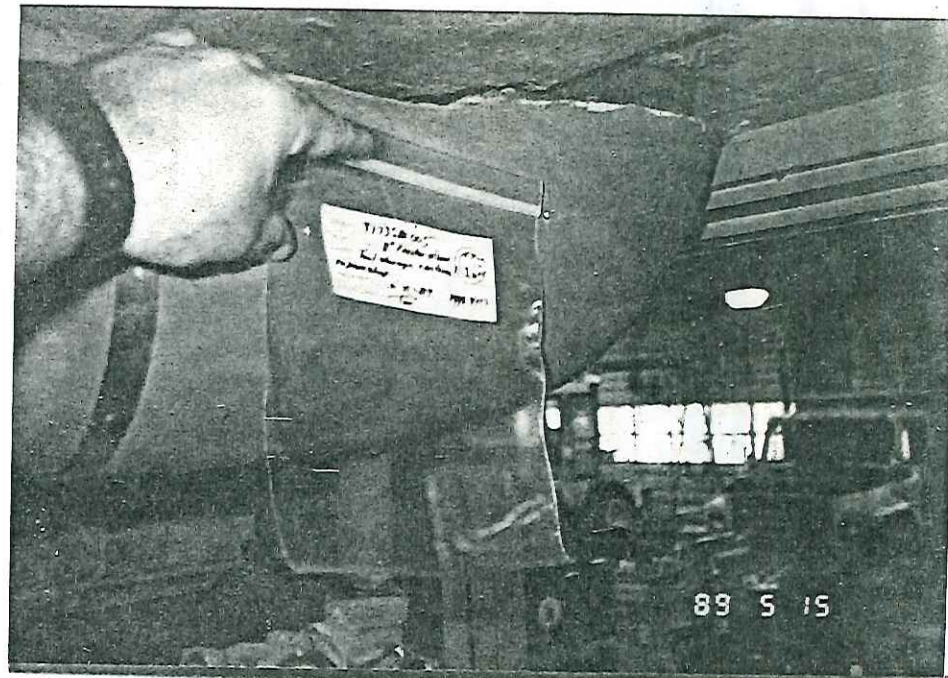
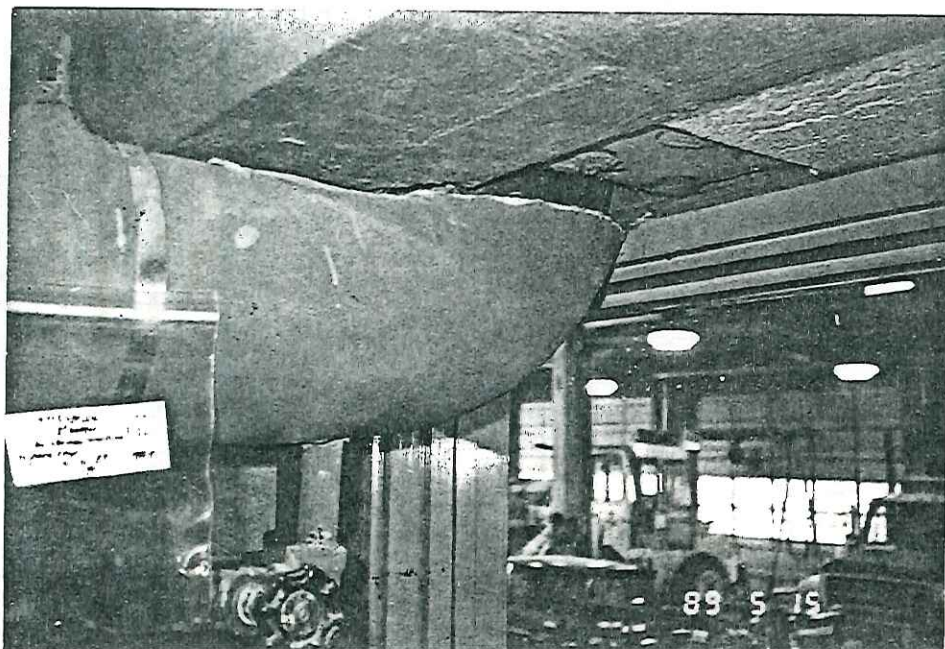
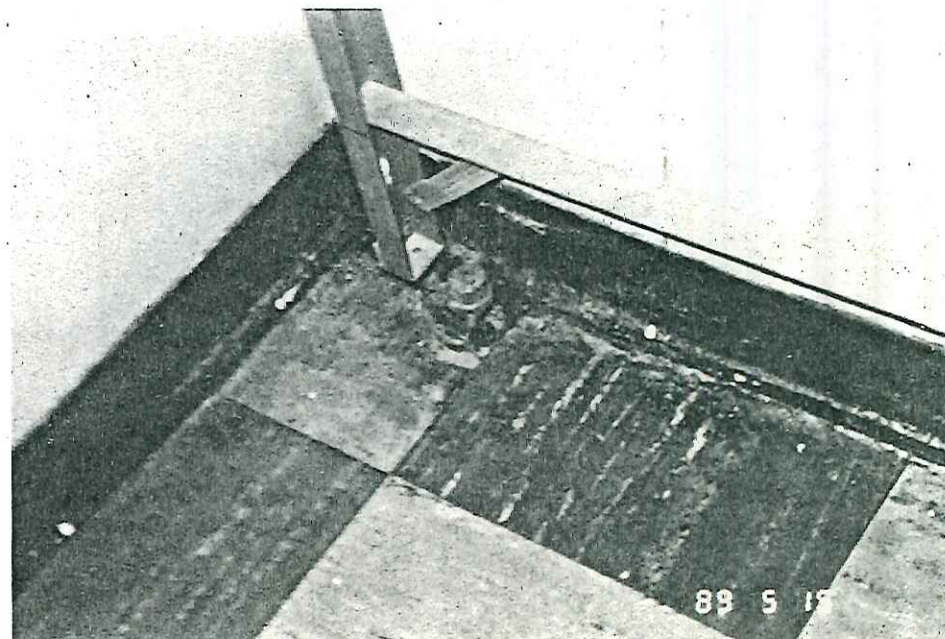
- 7 Tool Room - Plaster Fitting, 12' above floor (SM005)
- 8 Break Room - 12" Floor Tile and Mastic (SM003)
- 9 Tool Room - Plaster Hanger, 12' above floor (SM006)
